# OPERATION OF A HAYNES ALLOY NO. 25 FORCED CIRCULATION LOOP TO STUDY THE EFFECTS OF HYDROGEN IN A SIMULATED SUNFLOWER SYSTEM

*by R. C. Schulze and D. B. Cooper*

Prepared under Contract No. NAS 5-462 by  
THOMPSON RAMO WOOLDRIDGE, INC.  
Cleveland, Ohio

NATIONAL AERONAUTICS AND SPACE ADMINISTRATION • WASHINGTON, D. C. • MAY 1965

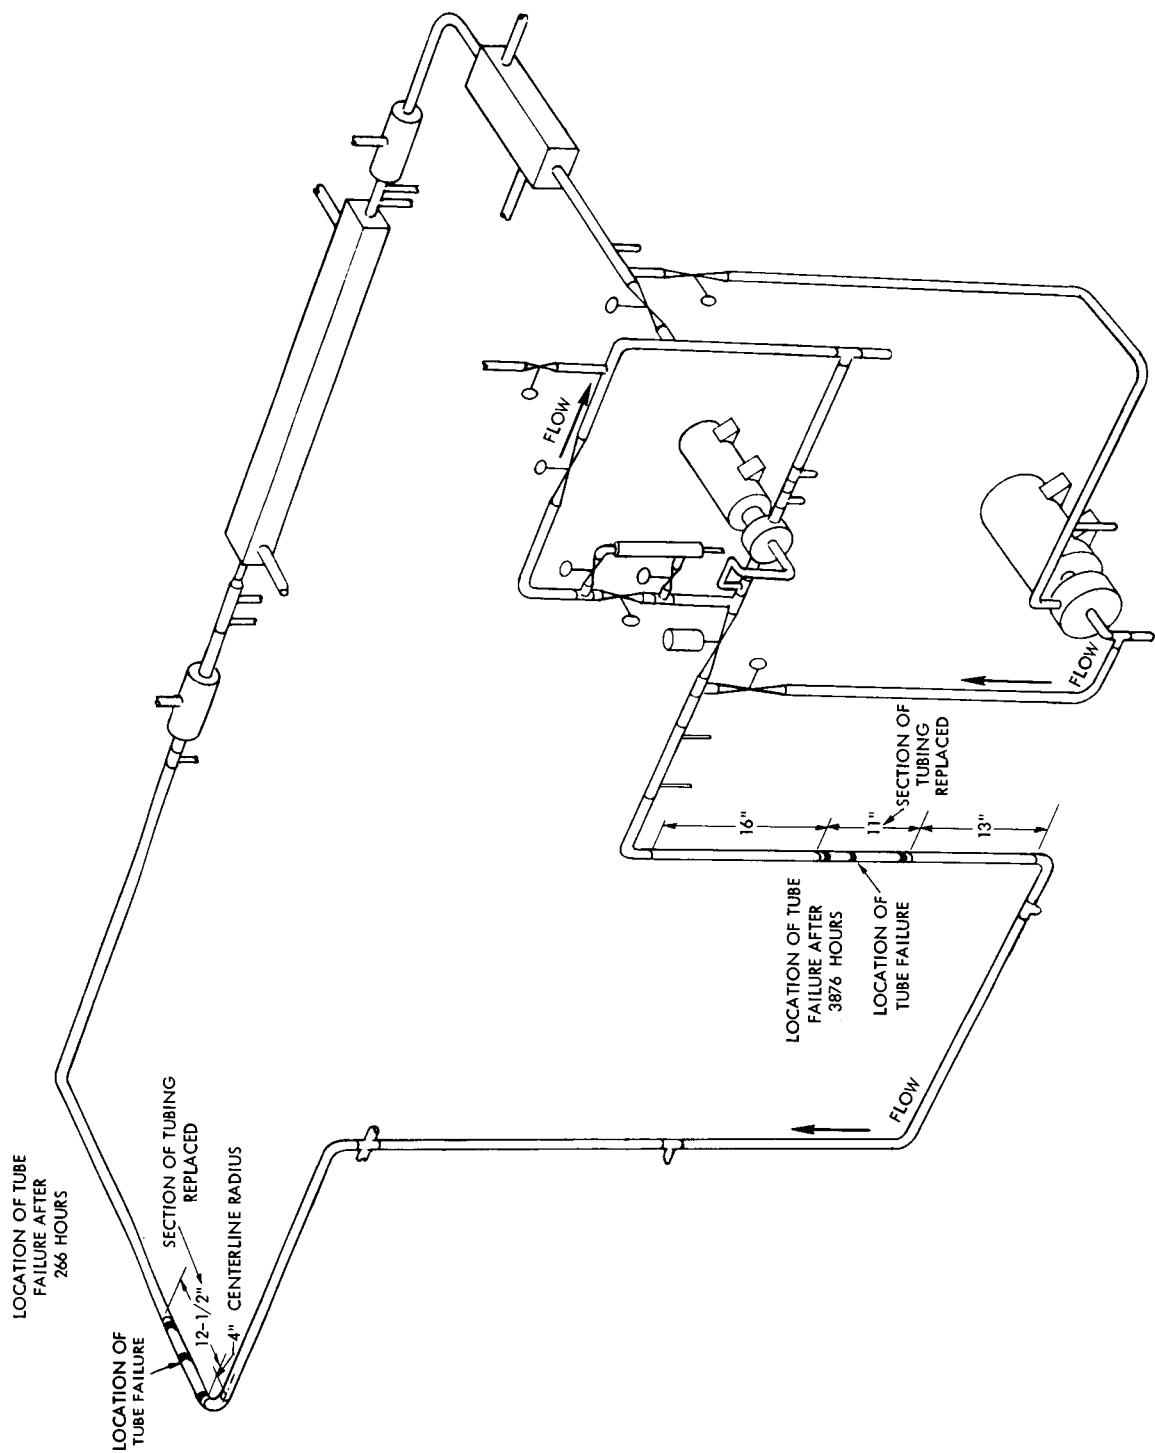
FIGURE 11 ISOMETRIC SKETCH OF THE LOOP SHOWING THE LOCATIONS OF THE TUBE FAILURES WHICH OCCURRED AFTER 266 AND 3876 HOURS

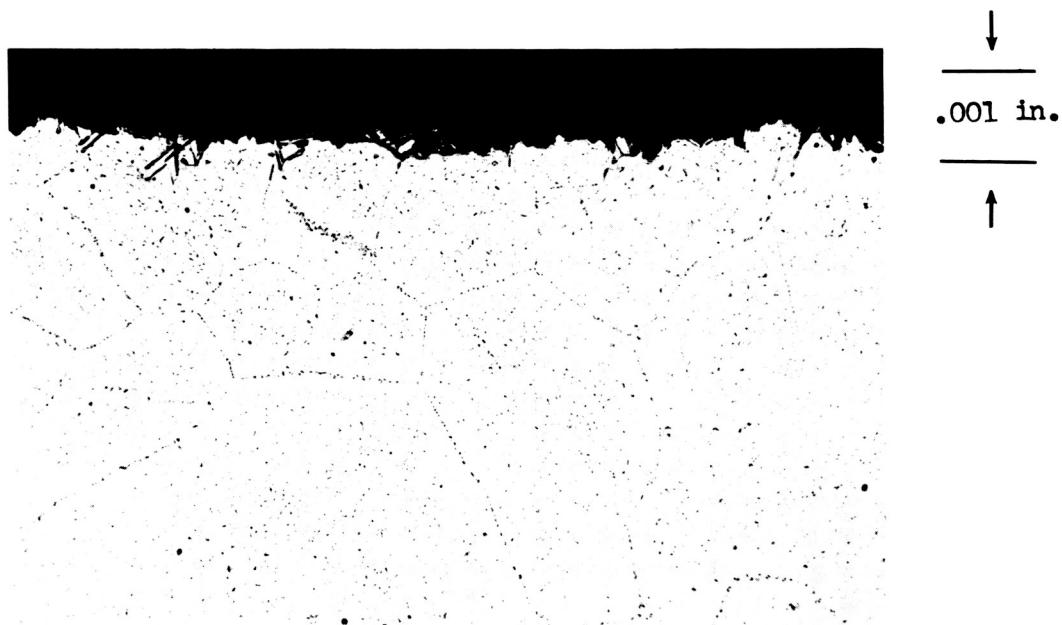
Figure 37. I.D. Surface of Specimen Removed from the Outlet Region  
of the Superheater (Section No. 26A, Thermocouple No. 24).

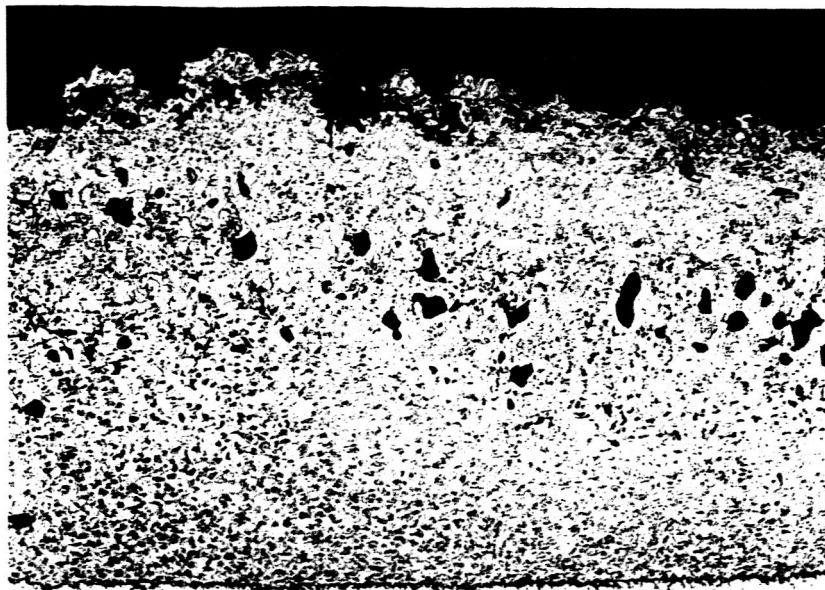
Along with the attack, deposits of corrosion products were found along the tube wall within the superheater. These deposits were metallic in appearance and appeared to be metallurgically bonded to the inside surface of the tubing. The greatest amount was found in the superheater inlet (Section 20 and 20A). Section 20A was removed after 3833 hours so that the crud separator could be installed in the superheater. Figure 38 (Section 20, thermocouple SH 1) shows the general appearance of the deposit at 100 magnification. In this region, the deposit was rather uniform in nature as shown in Figure 39 (macrograph of a portion of Section 20). The thickness of the deposit varied from 0 to .03 in. in depth.

Figure 38. Appearance of Deposit Found on the I.D. Surface of the Specimen Removed from the Superheater Inlet (Section 20, Thermocouple No. SH 1).

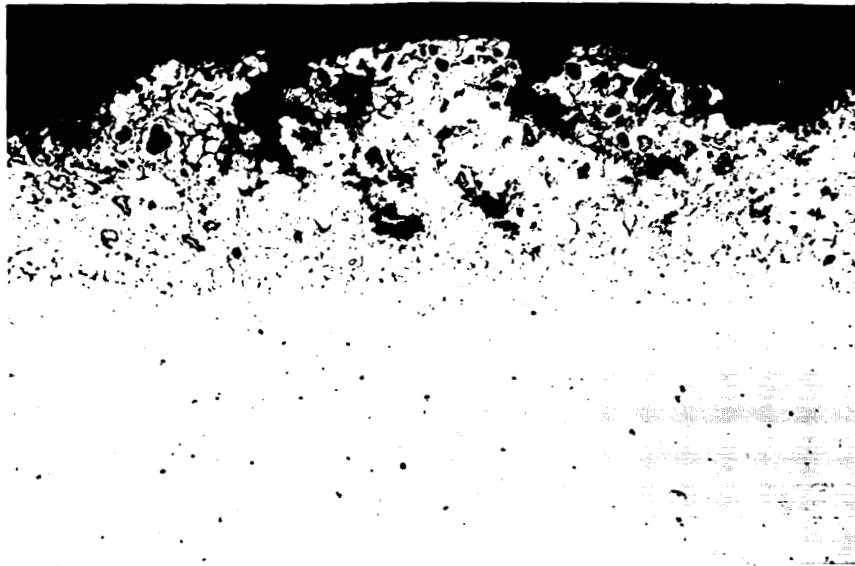
Figure 41. Appearance of Deposit Found Along the I.D. Surface of the Specimen Removed from the Middle Region of the Superheater (Section No. 22, Thermocouple No. 22).

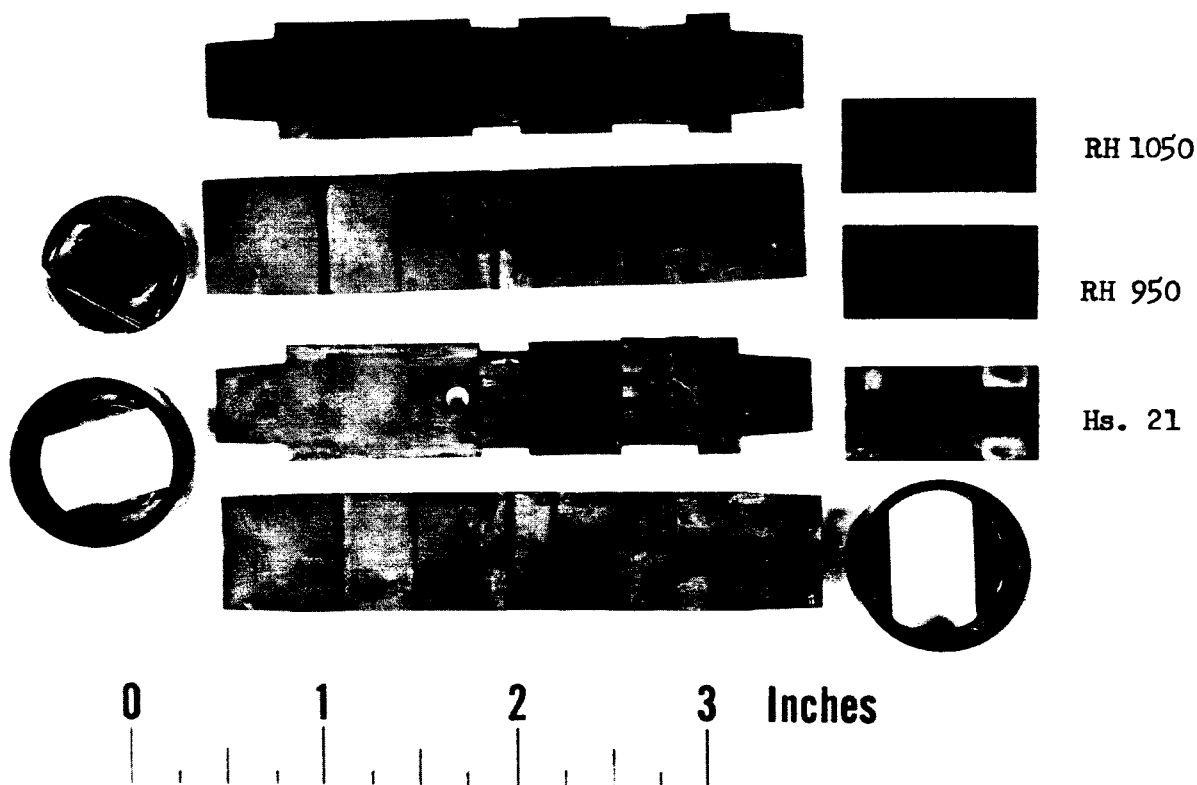
Figure 50. Appearance of Orifice and Specimen Holder Assembly After Test. Actual size.

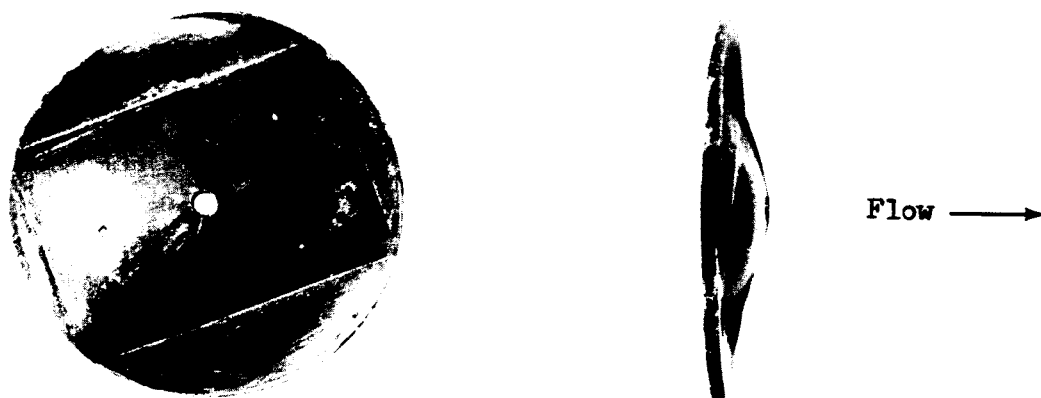
Figure 51. Macrograph of the Orifice Plate Showing the Amount of Distortion Incurred. Mag. 2.6X

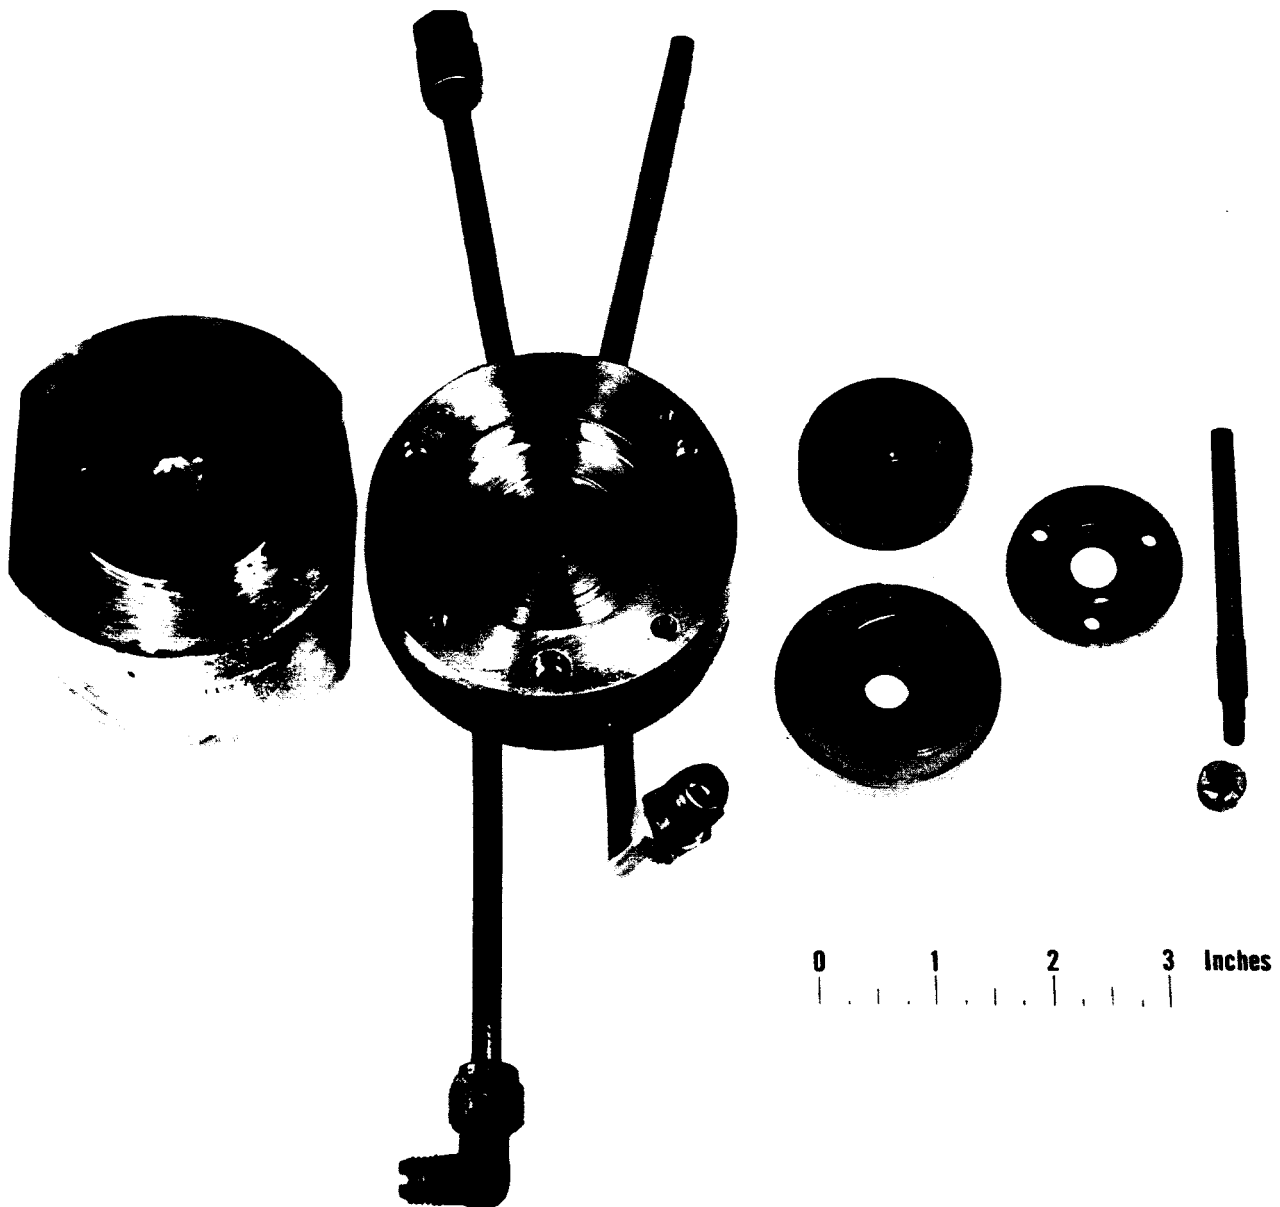
Figure 55. Condition of Centrifugal Pump Components After Test.  
Size of components reduced to three-quarters original size.

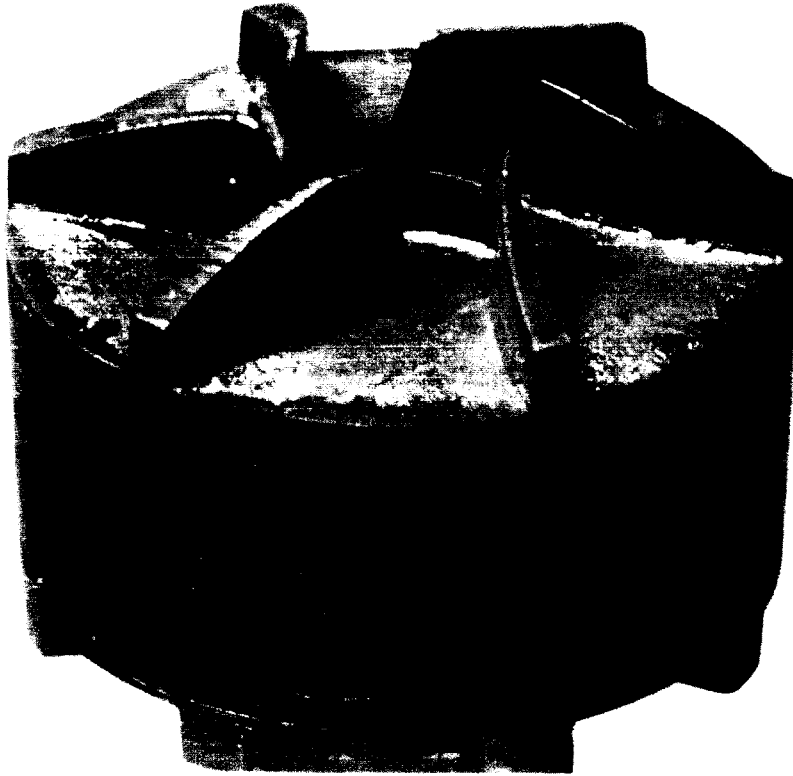
Figure 58. Macrographs of the Centrifugal Pump Impeller Showing the After Test Condition. Impeller was fabricated of Type 316 Stainless Steel.
